State of Nevada  
Department of Public Safety  
Division of Parole and Probation  
Campos Office Complex Site  
Facility Condition Analysis

# **CAMPOS OFFICE & PARKING COMPLEX SITE**

215 East Bonanza Blvd.  
Las Vegas, Nevada 89101

**Site Number: 9794**  
**STATE OF NEVADA PUBLIC WORKS DIVISION**  
**FACILITY CONDITION ANALYSIS**

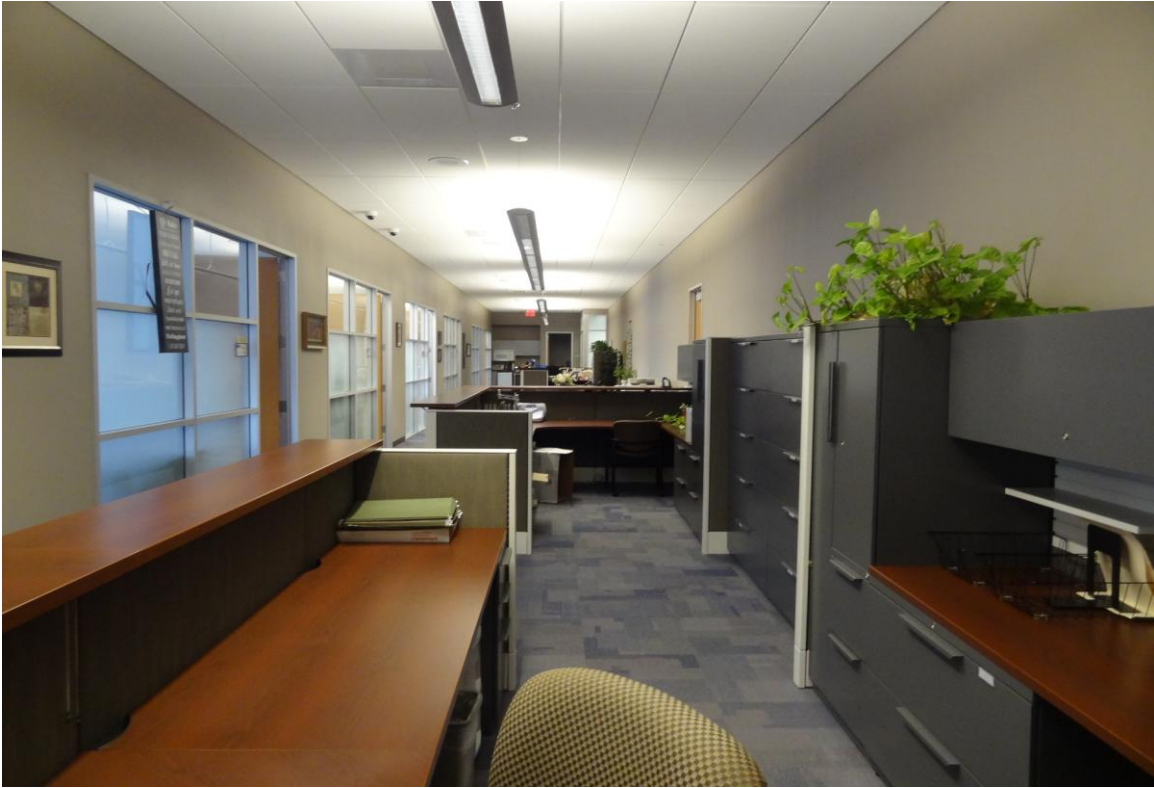
Campos Office & Parking Complex Site – FCA Building #2790  
Description: Interior office space.

The interior finishes are in fair condition. It is recommended to paint the interior walls and ceilings at least once in the next 2-3 years and that this project be scheduled on a cyclical basis to maintain the integrity of the structure. Prior to painting, all surfaces should be repaired and prepped. An epoxy-based paint should be utilized in wet areas for durability.

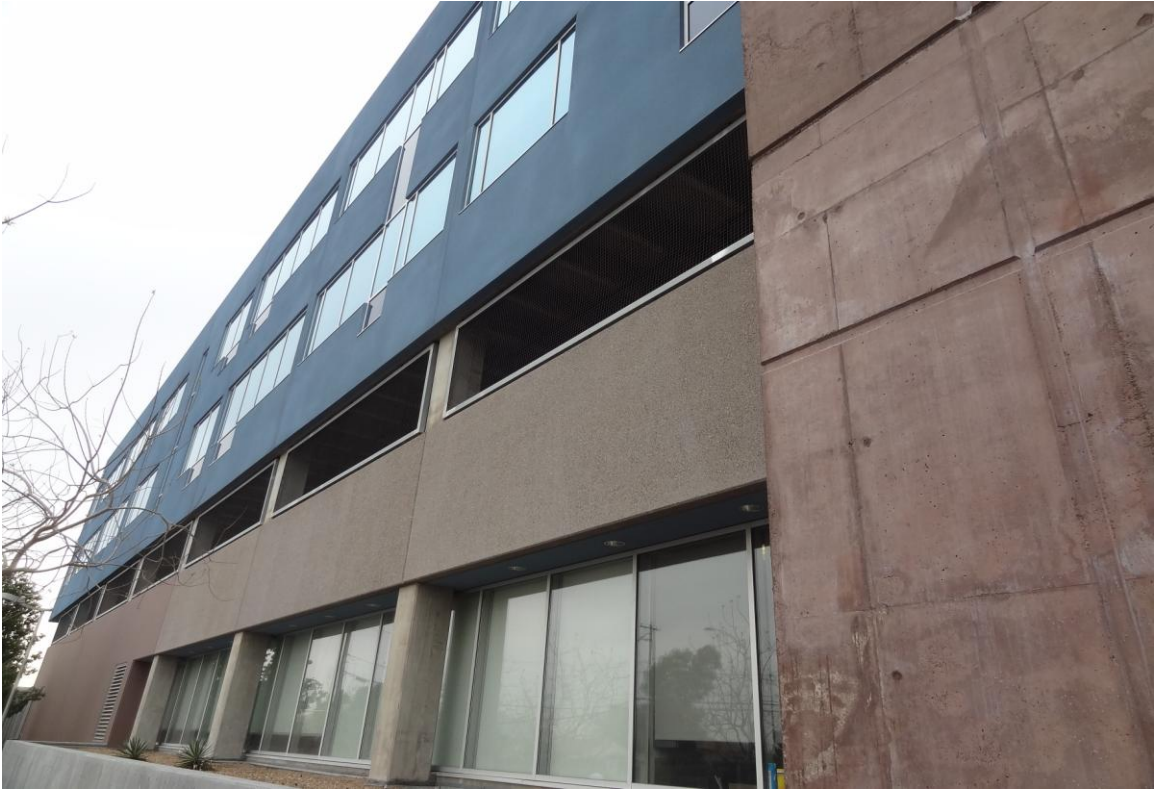
Campos Office & Parking Complex Site– FCA Building #2790  
Description: Exterior of the building.

It is important to maintain the finish, weather resistance and appearance of the building. This project would provide funding to protect the exterior of the building excluding the roof. Included in the cost is power washing, priming and painting and caulking of the joints, windows, flashing, fixtures and all other penetrations. It is recommended that the building be painted in the next 2-3 years and that this project be scheduled on a cyclical basis to maintain the integrity of the structure.
